DARBI KRUMPOS

Imperial Repairs High Above Kakaako

Remediation for leaky penthouse windows requires custom fabrication of replacement components

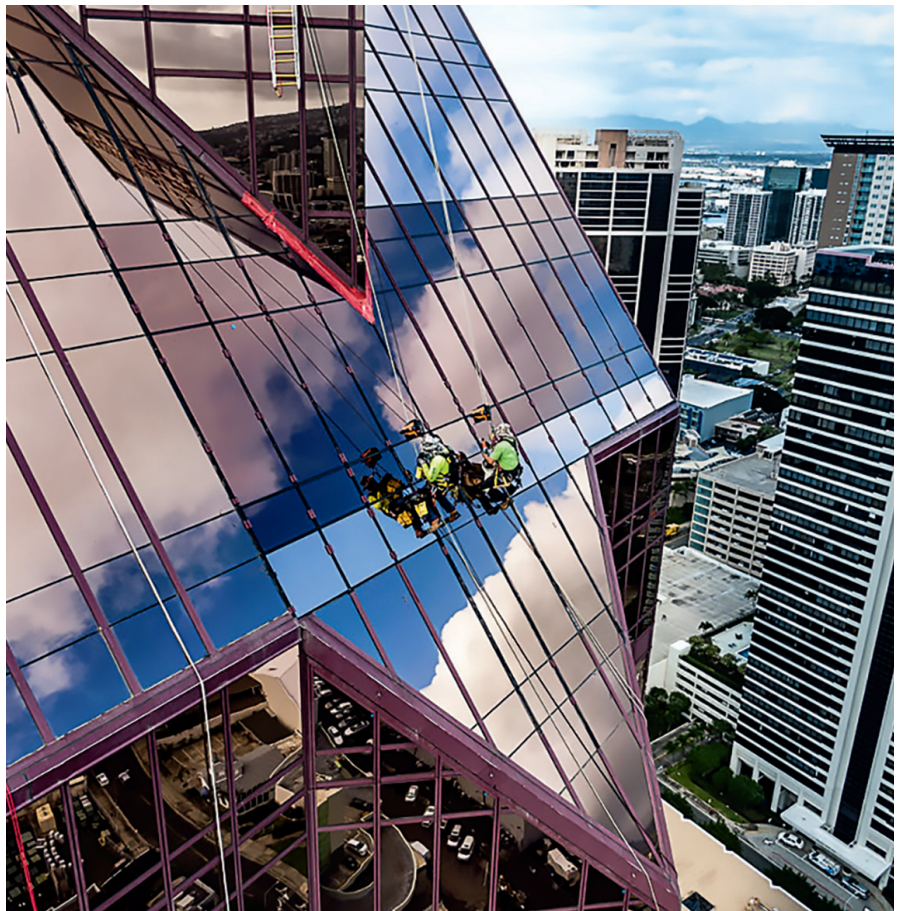
Water entry through the glazing and related seals was ongoing for more than a decade as components began to age. The components of the glazed façade move where connected to one another and where the window system transitions with concrete, steel and other building elements that move as a result of wind, thermal changes and material

degradation. Maintenance protocols relied upon contractors finding breaks in the gaskets or seals and attempting to seal them. Though initially successful, the need for a more effective and permanent approach was clear.

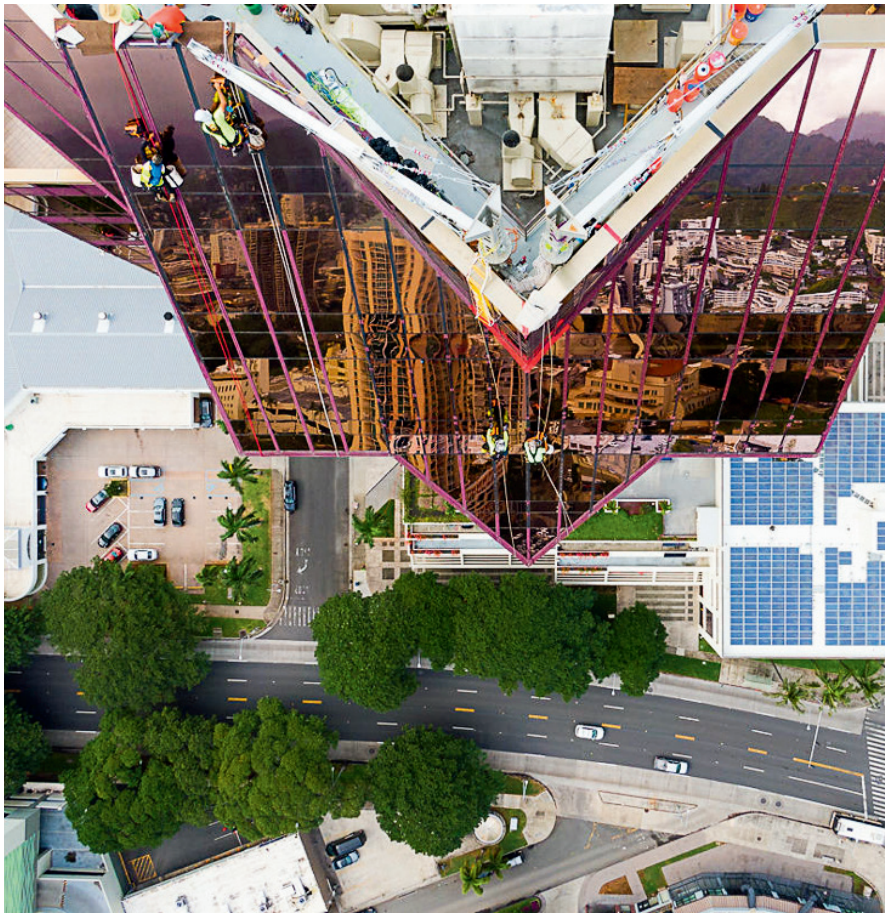
The clarity of the new custom glazing, especially when viewed side-by-side with the original glass, is striking in contrast. It shows the extent of the weathering of the existing elements and the advances in laminated glazing over the past 30 years.

From a distance, the change is unnoticeable. From inside the units, the clarity of the new glazing enhances the beautiful views.
